BROOKHAVEN NATIONAL LABORATORY

Phase 2 Work Plan for the Characterization of Per- and Polyfluoroalkyl Substances (PFAS) in Known or Suspected Firefighting Foam Release Areas

July 31, 2018

Groundwater Protection Group
Environmental Protection Division
Brookhaven National Laboratory
Upton, New York 11973

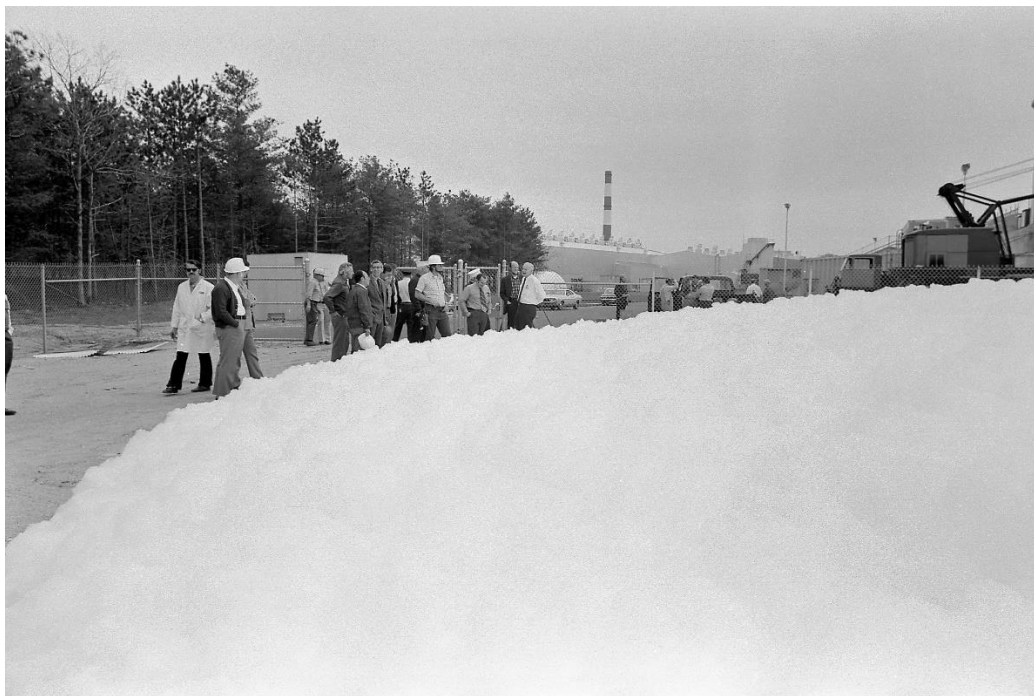
Figure 11. Release of high-expansion foam at the former Bubble Chamber area. April 1973.

History: Due to the use of flammable scintillation fluid at the former Bubble Chamber experiment (former Building 960), BNL installed a high-expansion foam fire suppression system in the building that housed the experiment. In April 1973, BNL conducted a test of the suppression system which resulted in the release of a large volume of high-expansion foam outside of the building (**Figure 11**). There are no records on the formulation or volume of foam concentrate that was used. Available photographs show that the area surrounding the Bubble Chamber building was unpaved. Three months later, in July 1973, the fire suppression system accidentally released foam inside the Bubble Chamber building. The foam spread out of the building and onto the ground outside. The foam was washed down with water. In 1980, the foam suppression system was tested prior to its decommissioning, and the foam released during the test was directed outside. The former Bubble Chamber building was subsequently demolished.

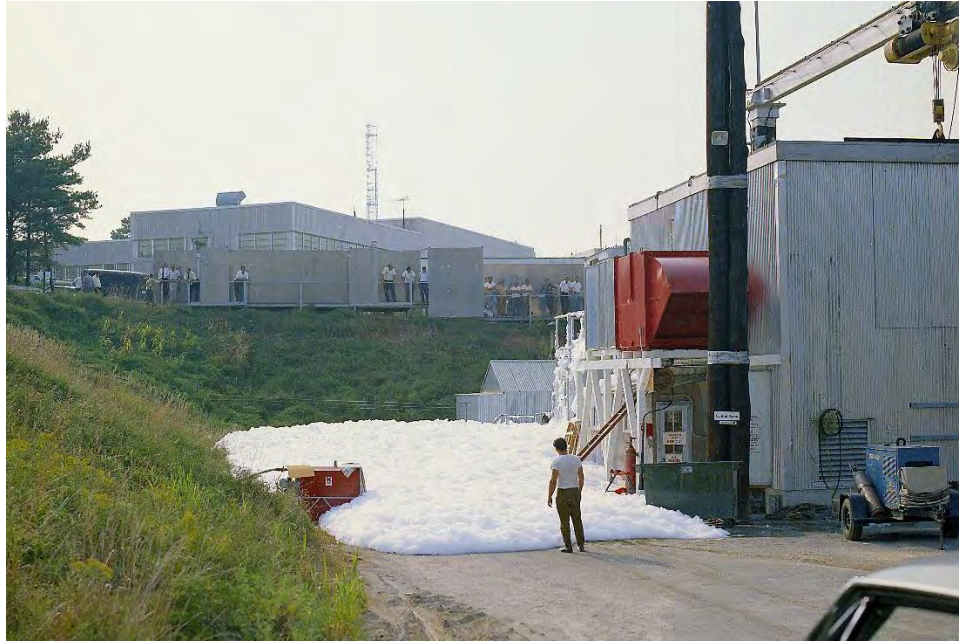
Figure 13. Release of high-expansion foam in area east of Building 902. September 1970.

History: In September 1970, a second high-expansion foam test was conducted as part of the development effort for a fire suppression system needed for the Bubble Chamber building. Photographic records show that a large volume of high-expansion foam was released from an experiment building onto a partially paved area located east of Building 902 (**Figure 13**). The experiment building was subsequently demolished, and the area was backfilled with 5 to 10 feet of soil. There are no records on the formulation or volume of foam concentrate that was used. Because there are no storm water drains in the release area, it is likely that the foam was rinsed onto the surrounding soil area after the test.

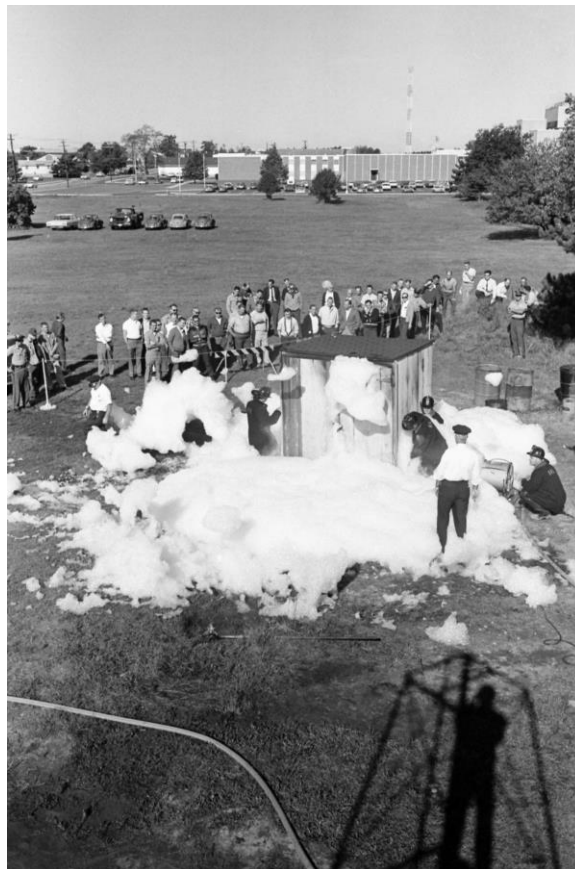
Figure 14. Training with high-expansion foam at the former firehouse. September 1966.

History: The former firehouse was in continuous operation from 1947 through 1985. Photographic records indicate that firefighting foam was used at the facility as early as 1966. Based upon discussions with current and former employees, firefighters routinely practiced with foam in a training area that was located immediately west of the firehouse (**Figure 7**). The training area was an open grass/dirt field (**Figure 14**). A second, infrequently used training area was located east of the firehouse. In this unpaved area, firefighters would periodically practice extinguishing car fires using foam. Furthermore, as part of routine maintenance of firetruck foam systems, foam was periodically discharge on the pavement in front of the firehouse. There are no available records on the foam formulations used over this period or the amount of foam that was released. The former Firehouse was demolished in ~1985-1986, and the surrounding area was regraded and seeded. Most of the training area that was located to the west of the firehouse is presently occupied by the former National Synchrotron Light Source building that was constructed in the 1980s. It is unknown whether excavation activities resulted in the removal of potentially PFAS contaminated soils from the construction area. Although there are presently

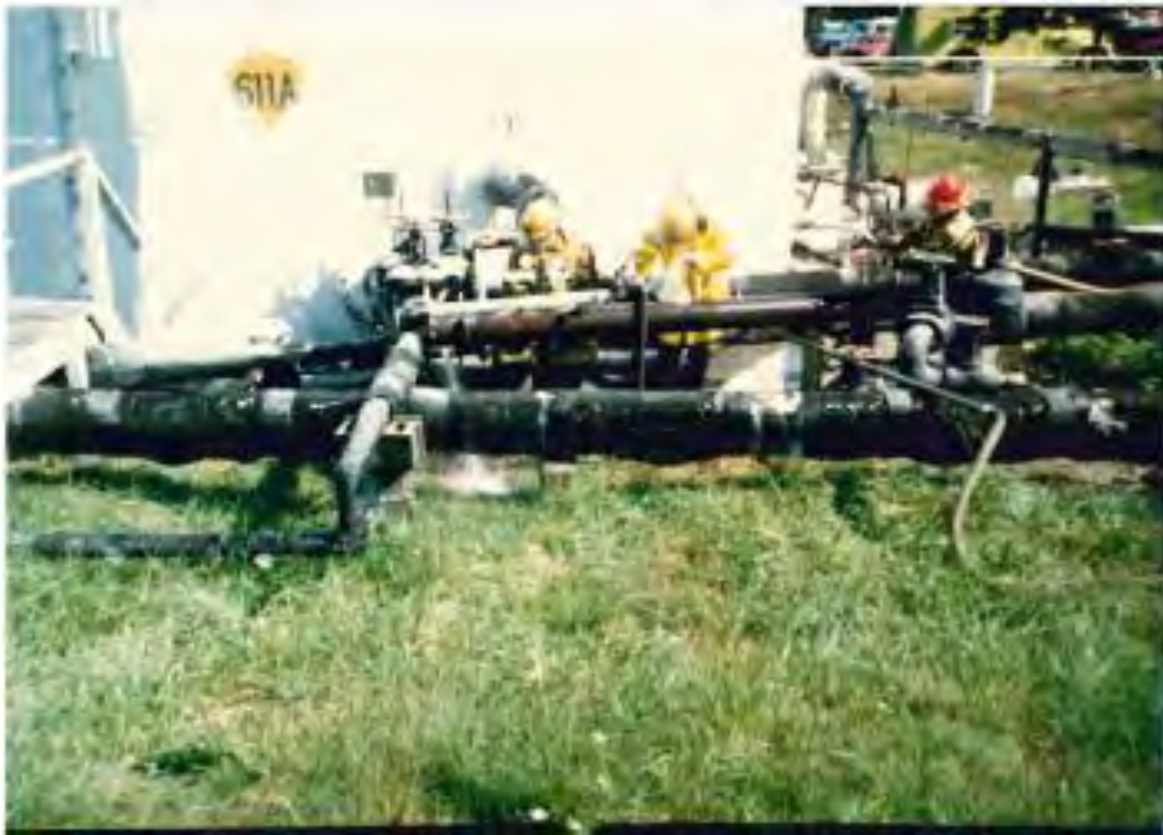
Figure 15. Training with low-expansion foam at the Major Petroleum Facility. September 1986.

History: In September 1986, low-expansion firefighting foam was used during a single day firefighting training exercise at the Major Petroleum Facility (MPF), within the containment berm of former above ground petroleum storage tank 611A (**Figure 15**). There are no records on the foam formulation or the amount that was used during the training. Although BNL's current containment berms are configured to allow for controlled releases of collected rain water to the sanitary system, a records search is required to locate information on berm drainage at the former tank area. There are no records or employee recollections of other training exercises being conducted in the MPF area.
